Beach Erosion and Sediment Processes Study, North East Marina, Erie County, Pennsylvania

Andrew Morang and Jeffrey Melton

June 2001

Final report

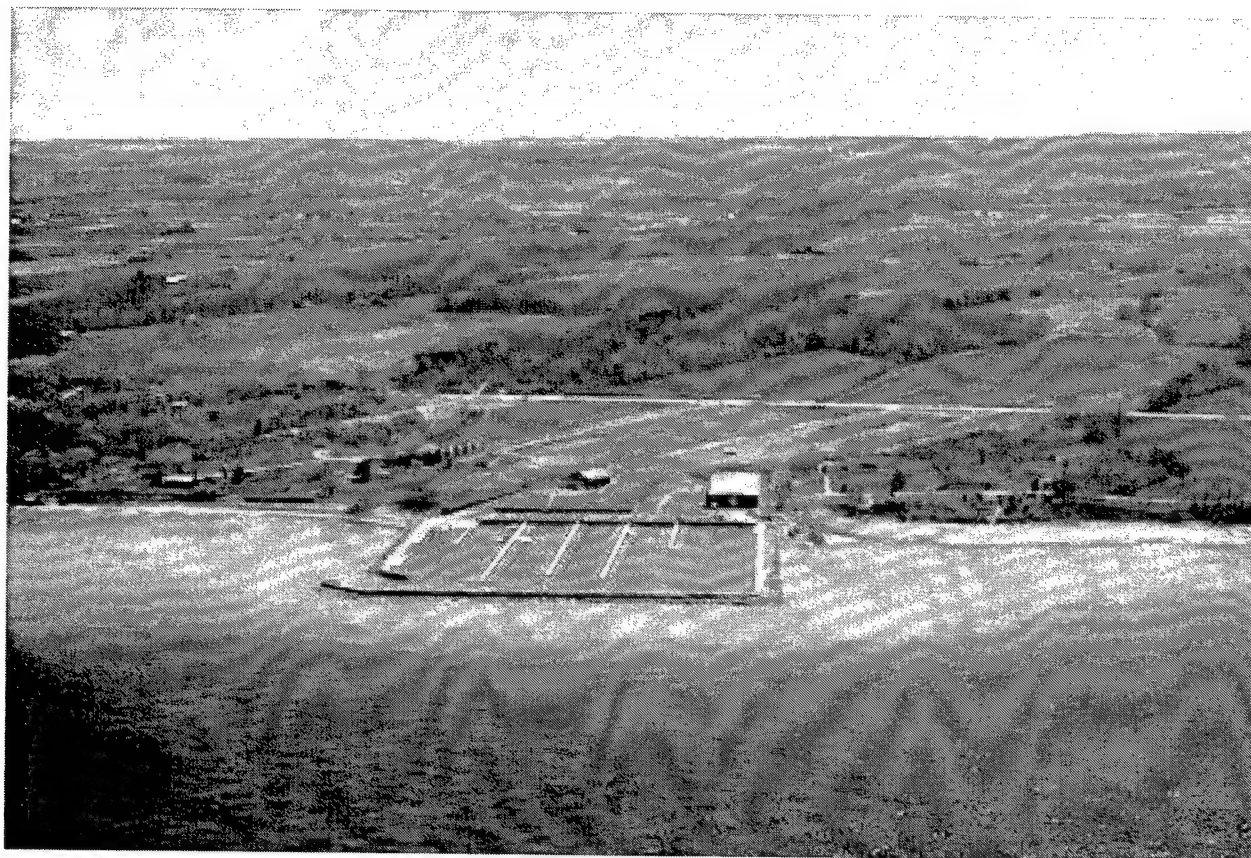
Figure 6. Oblique aerial photograph of marina looking southeast, April 1999. PFBC's spring bypassing operation is in progress, and a backhoe and truck are in the fillet on the right side of the marina. Photograph courtesy Buffalo District

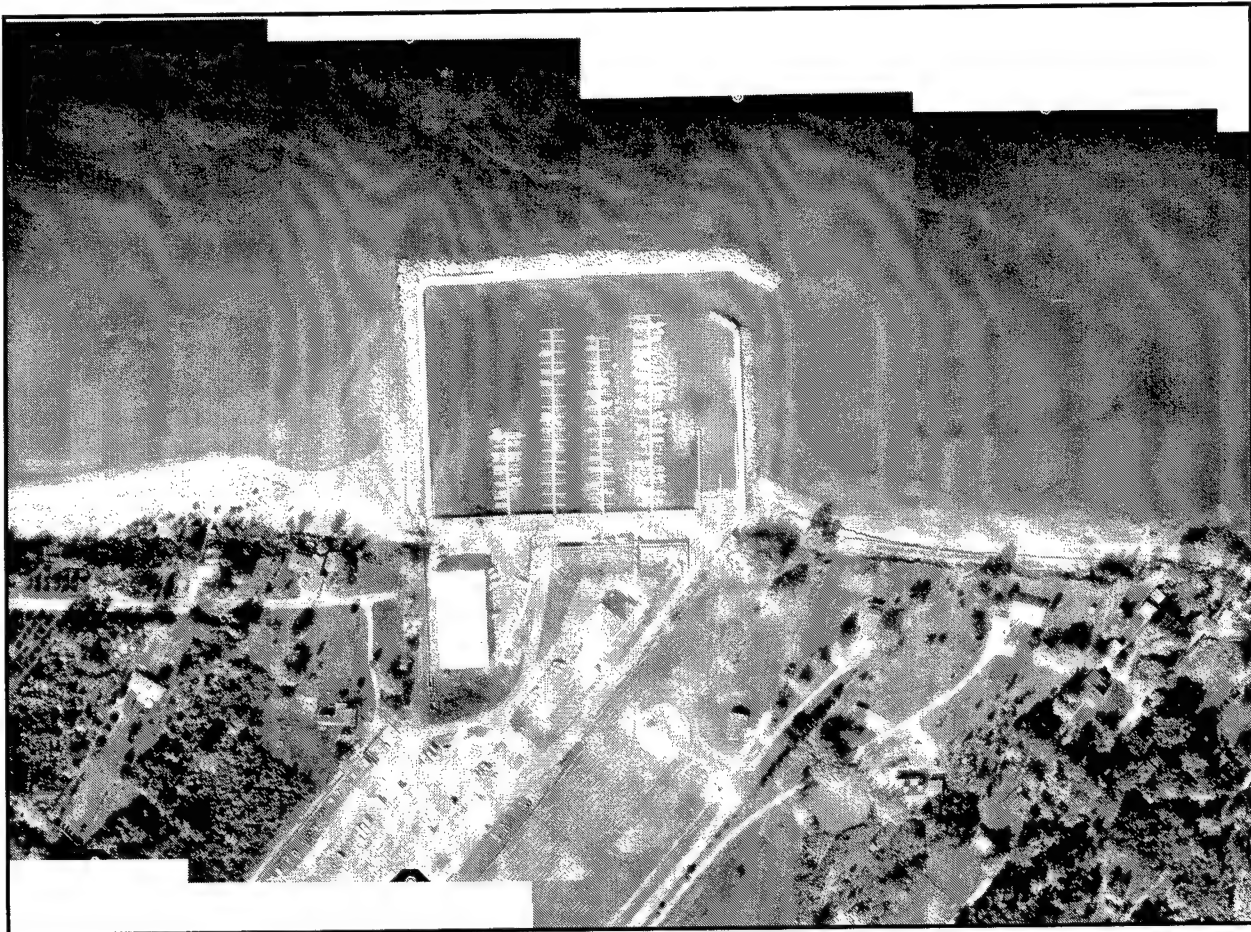
Figure 7. Vertical aerial photograph, October 15, 1999. Shale ledges can be seen through water east (to the right) and lakeward of marina. Bulge in shore west (left) of the marina is accretion on private property that PFBC is unable to mine during biannual bypassing operations

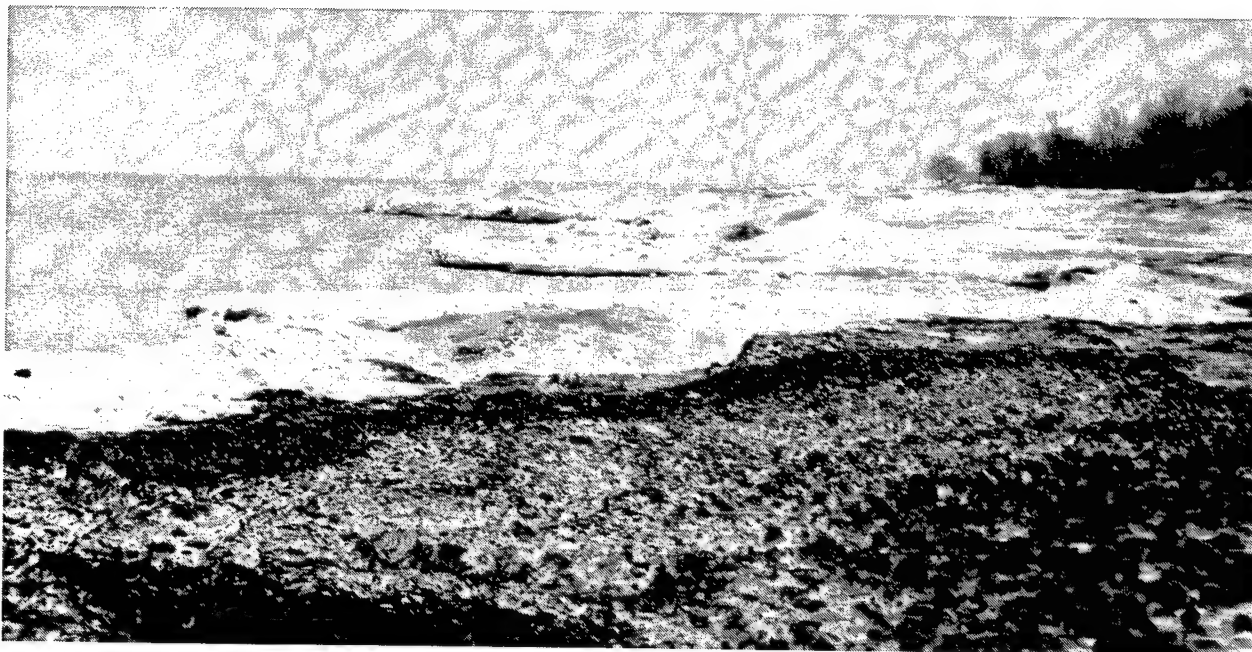
Figure 9. Ice armor along beach, 29 January 1999. During winter, ice protects shore from direct wave attack, but during spring thaw, ice blocks overturn, picking up masses of sand and gravel. View northeast towards Twentymile Creek. Photograph from Buffalo District archives

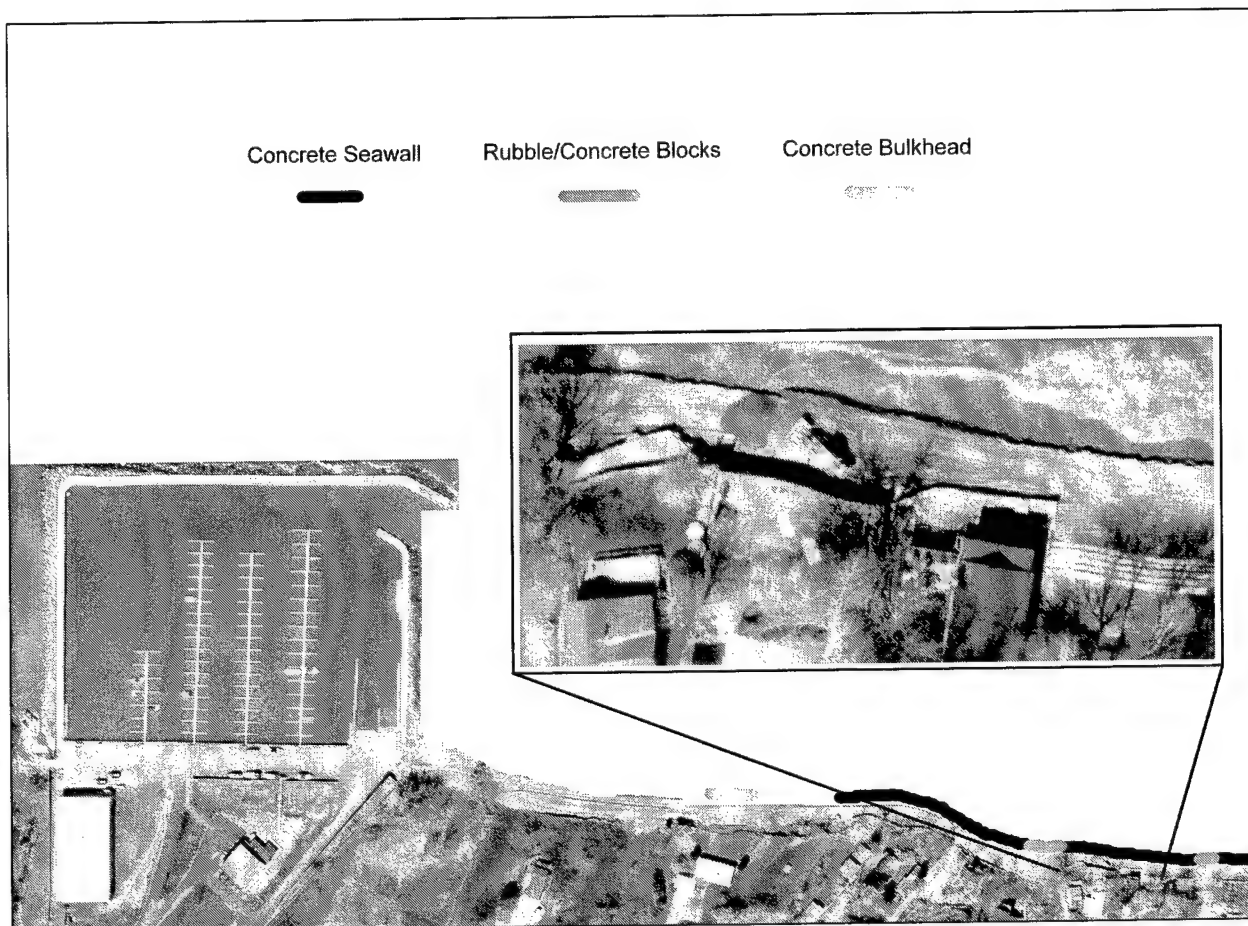
Figure 16. Armoring structures along the shore east of North East Marina (28 April 1999). All of these structures predate the marina. Insert shows a grader moving sand near one of the seawalls that project out from the bluff line

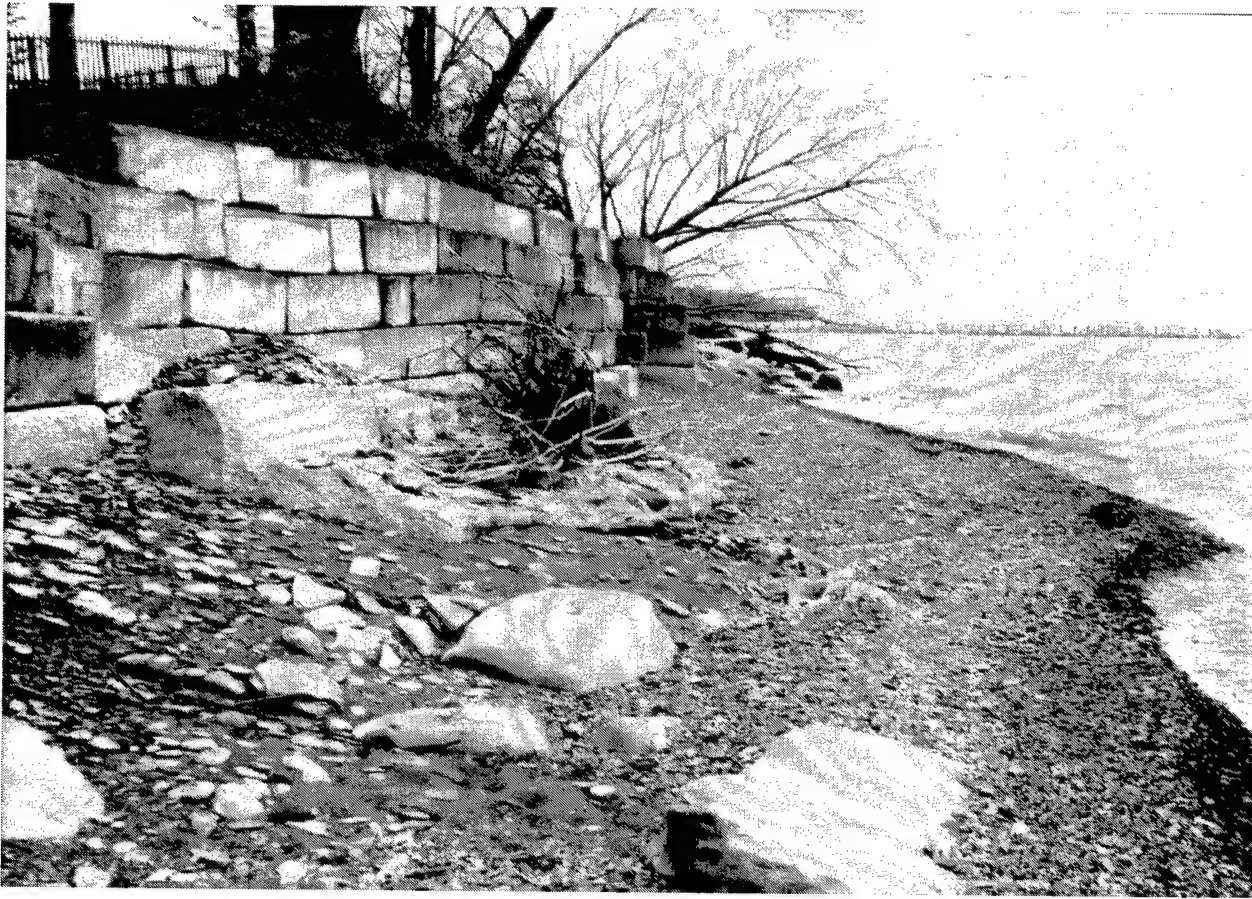
Figure 17. Concrete block wall about 200 m east of marina, 17 May 1991. Leaning tree is seen in subsequent figures

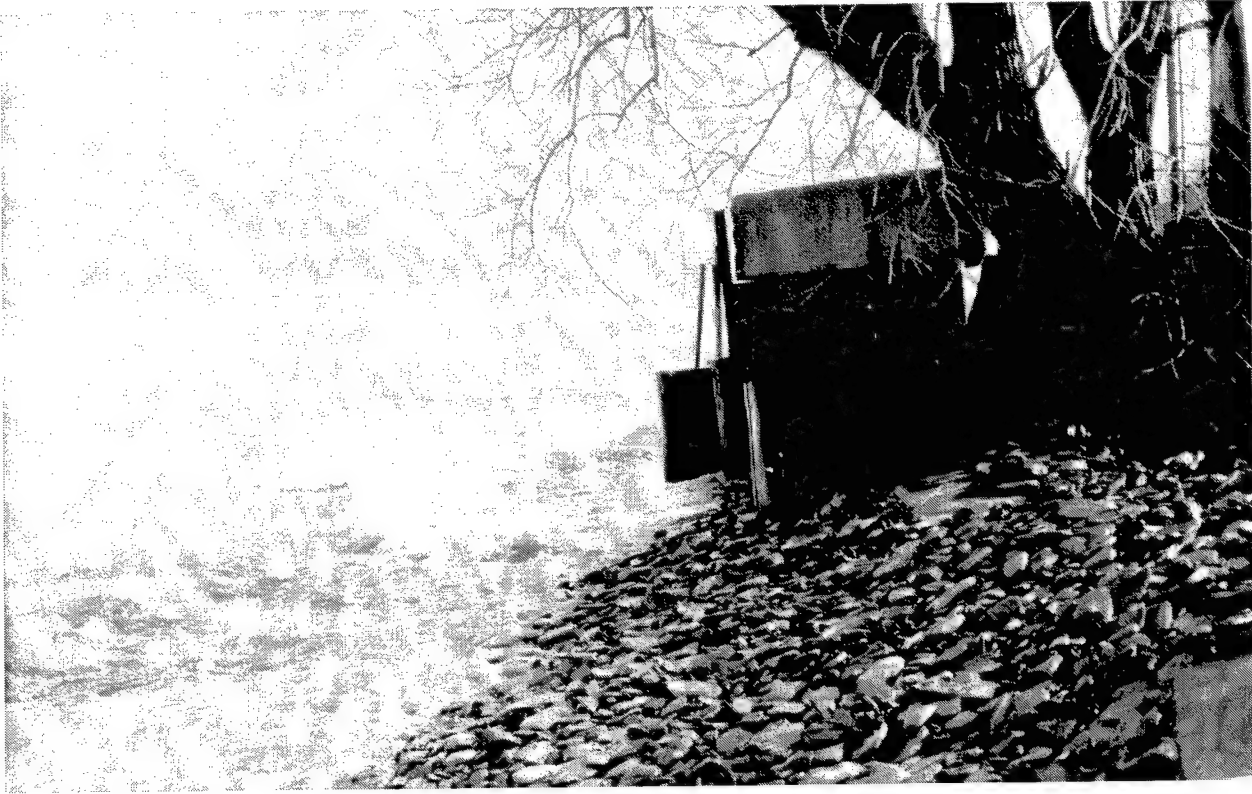
Figure 18. Exposed seawall March 1991, view east. Original photograph label states, "High water from storm just east of Kelley property" (Buffalo District archives)

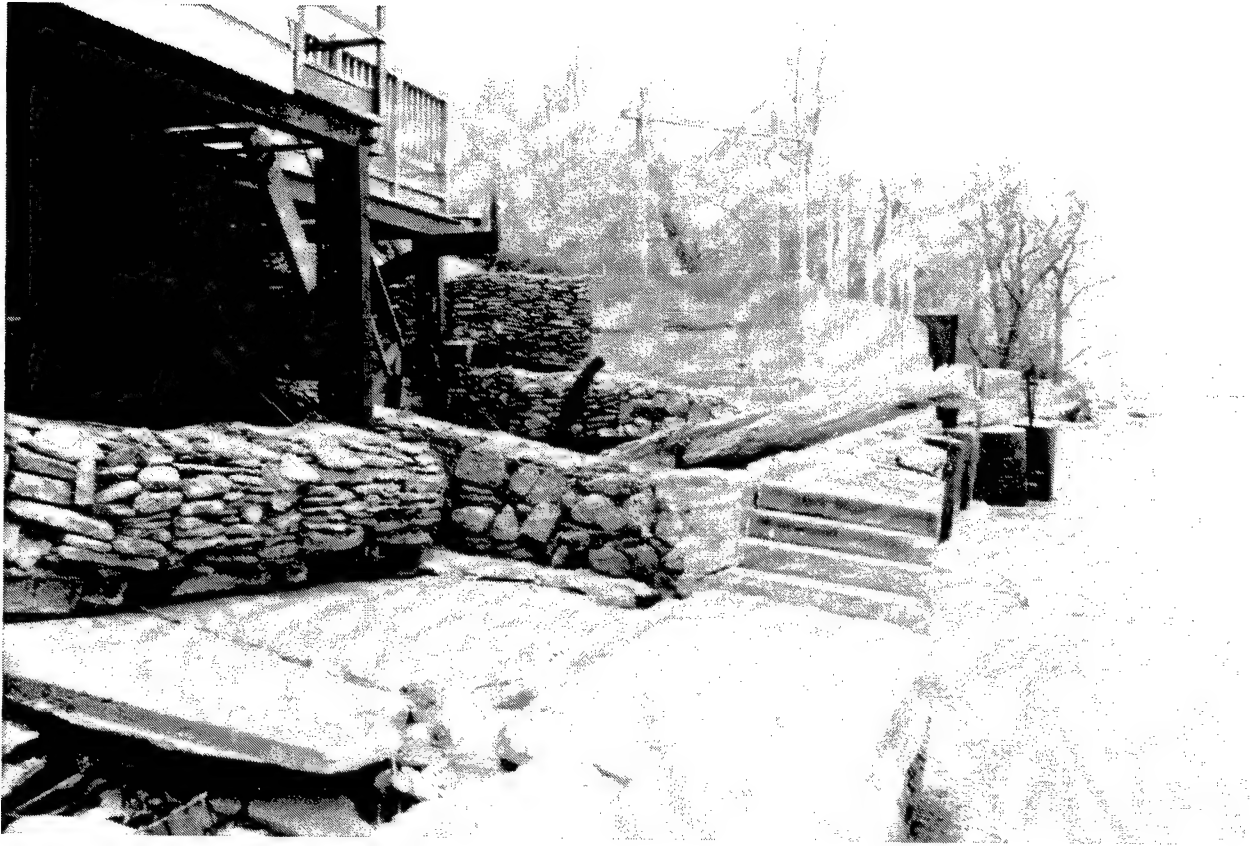
Figure 19. House protected with gabions, concrete, and concrete-filled tanks, May 1991. These structures are about 500 m east of marina's east wall (visible in right side of photograph). Notice tree trunk resting on wall next to steps, evidence of power of storm waves. When this photograph was taken, there was no beach at base of concrete slabs. Photograph from Buffalo District archives

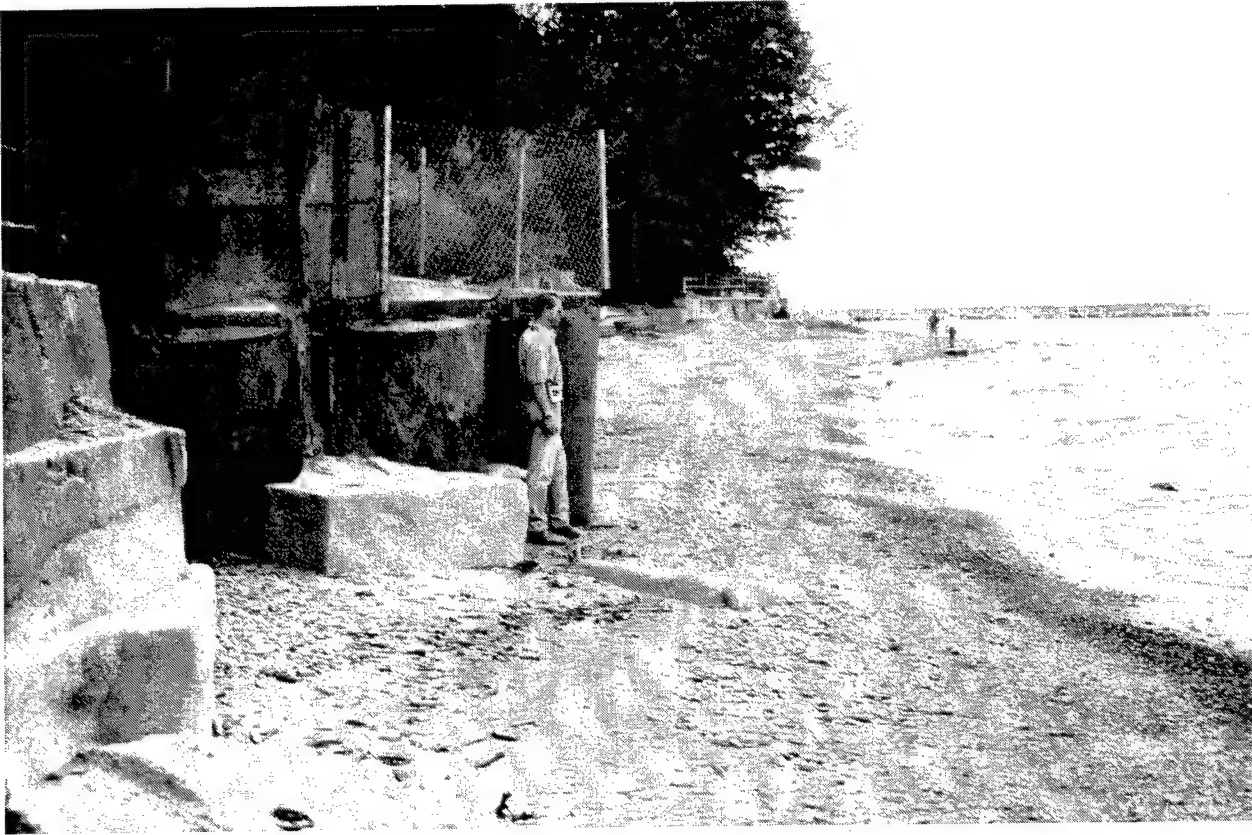
Figure 20. Gravel and sand beach below same structures shown in Figure 19. Beach is about 4 m wide. North East Marina east wall is in distance to right. Photograph taken 11 August 1999, before the autumn bypassing

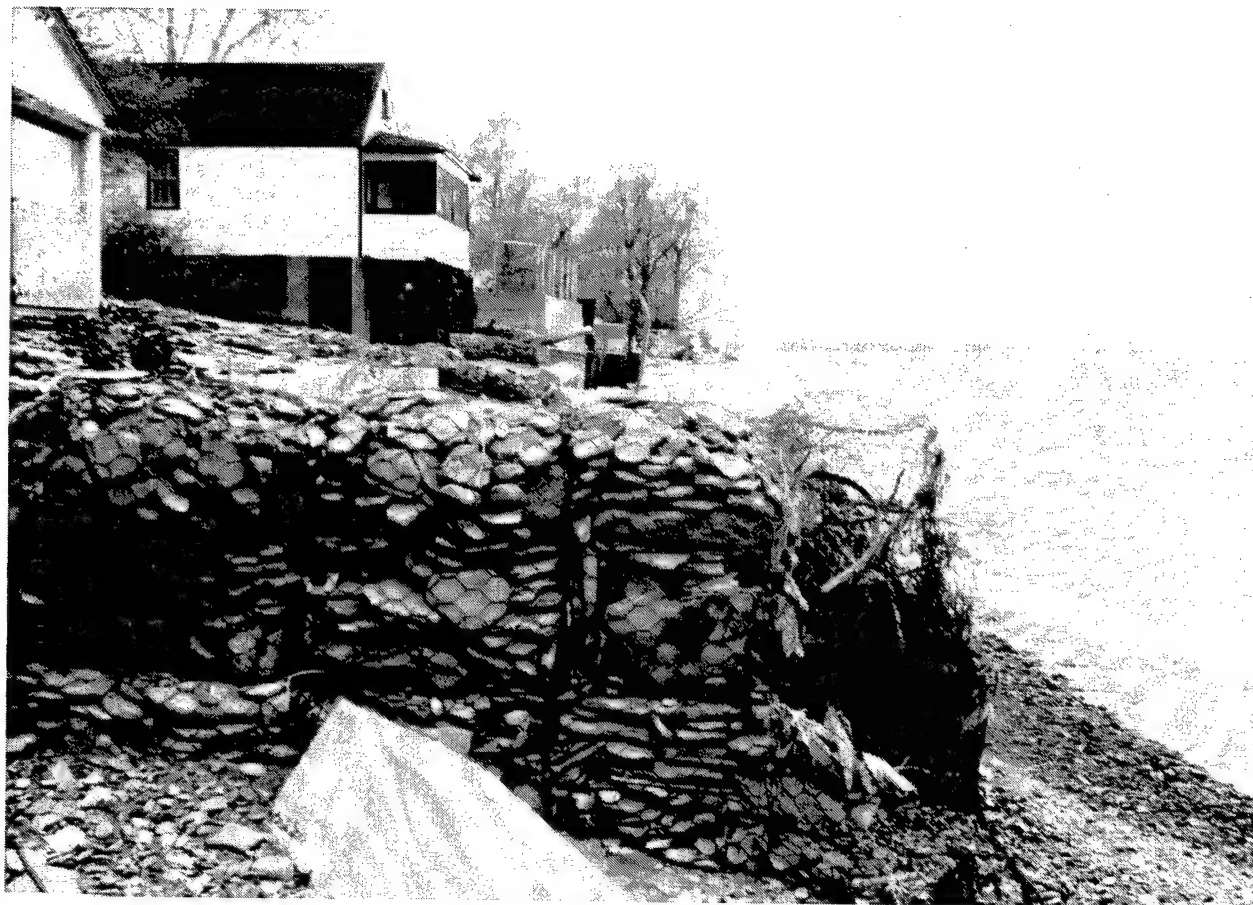
Figure 21. Gabion wall east of property shown in previous photographs, 17 May 1991. Leaning tree where concrete block walls are found is in distance. Photograph from Buffalo District archives

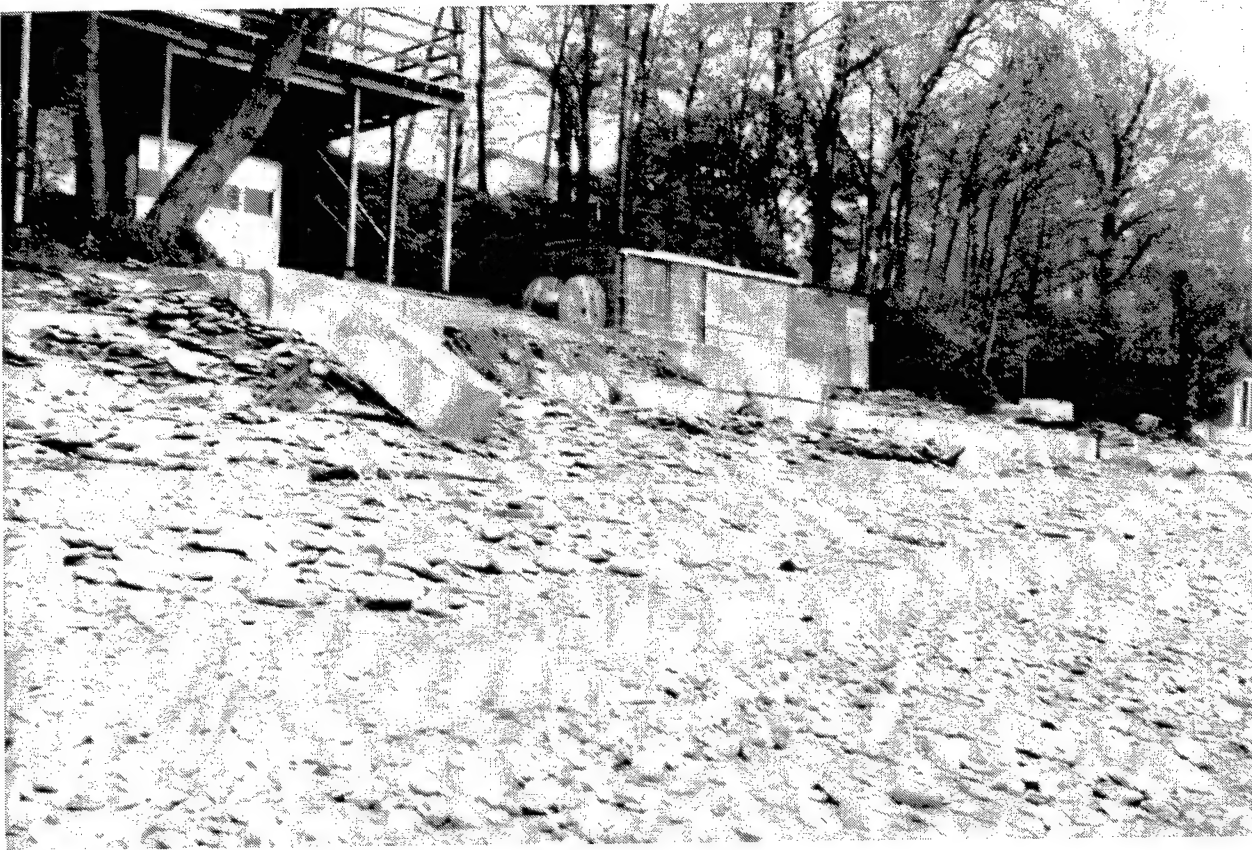
Figure 22. Cottage with protective concrete blocks east of the location shown in previous figures, 17 May 1991. Note the block that has been moved by storm waves. The three properties in the foreground are vulnerable to storm waves because they were built on the beach rather than up on the bluff like the house in the background. Photograph from Buffalo District archives

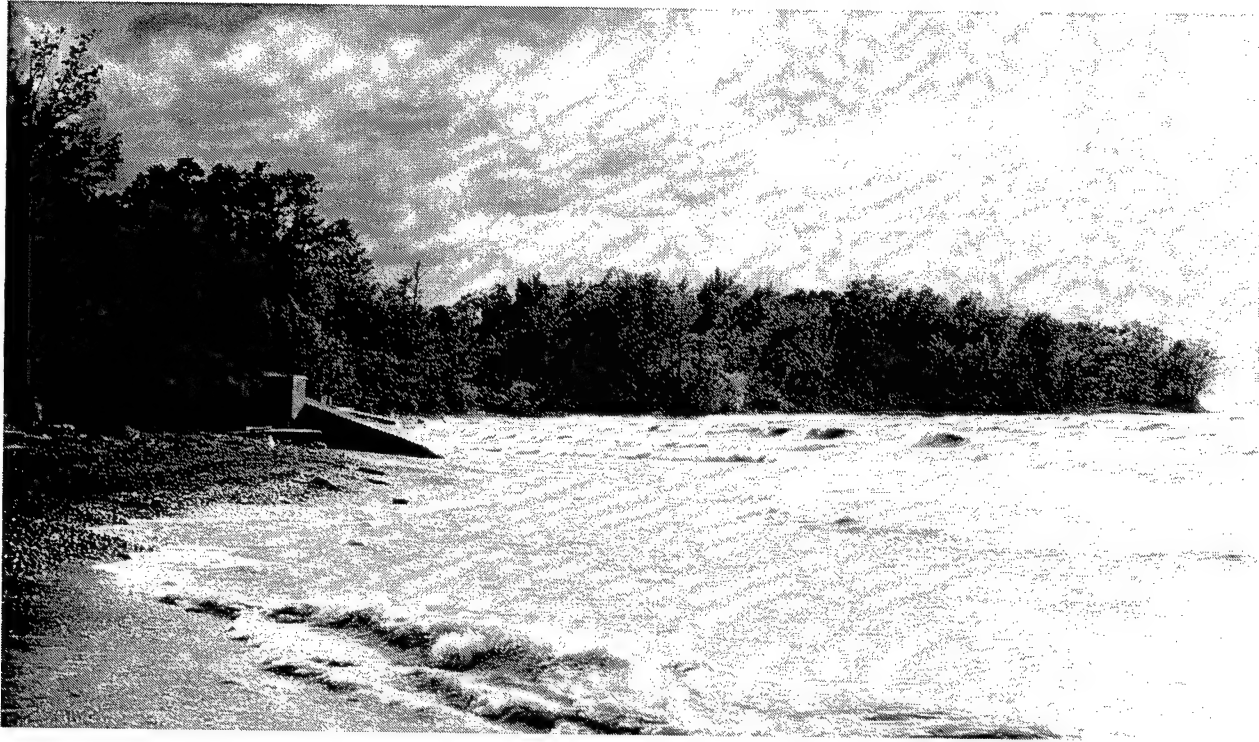
Figure 23. Seawall made of concrete-filled tanks west of North East Marina, November 1991. Most of the ramp and over two thirds of wall are now covered with sand and gravel. In 1991, beyond the walls, there was essentially no beach and waves broke directly at base of bluffs

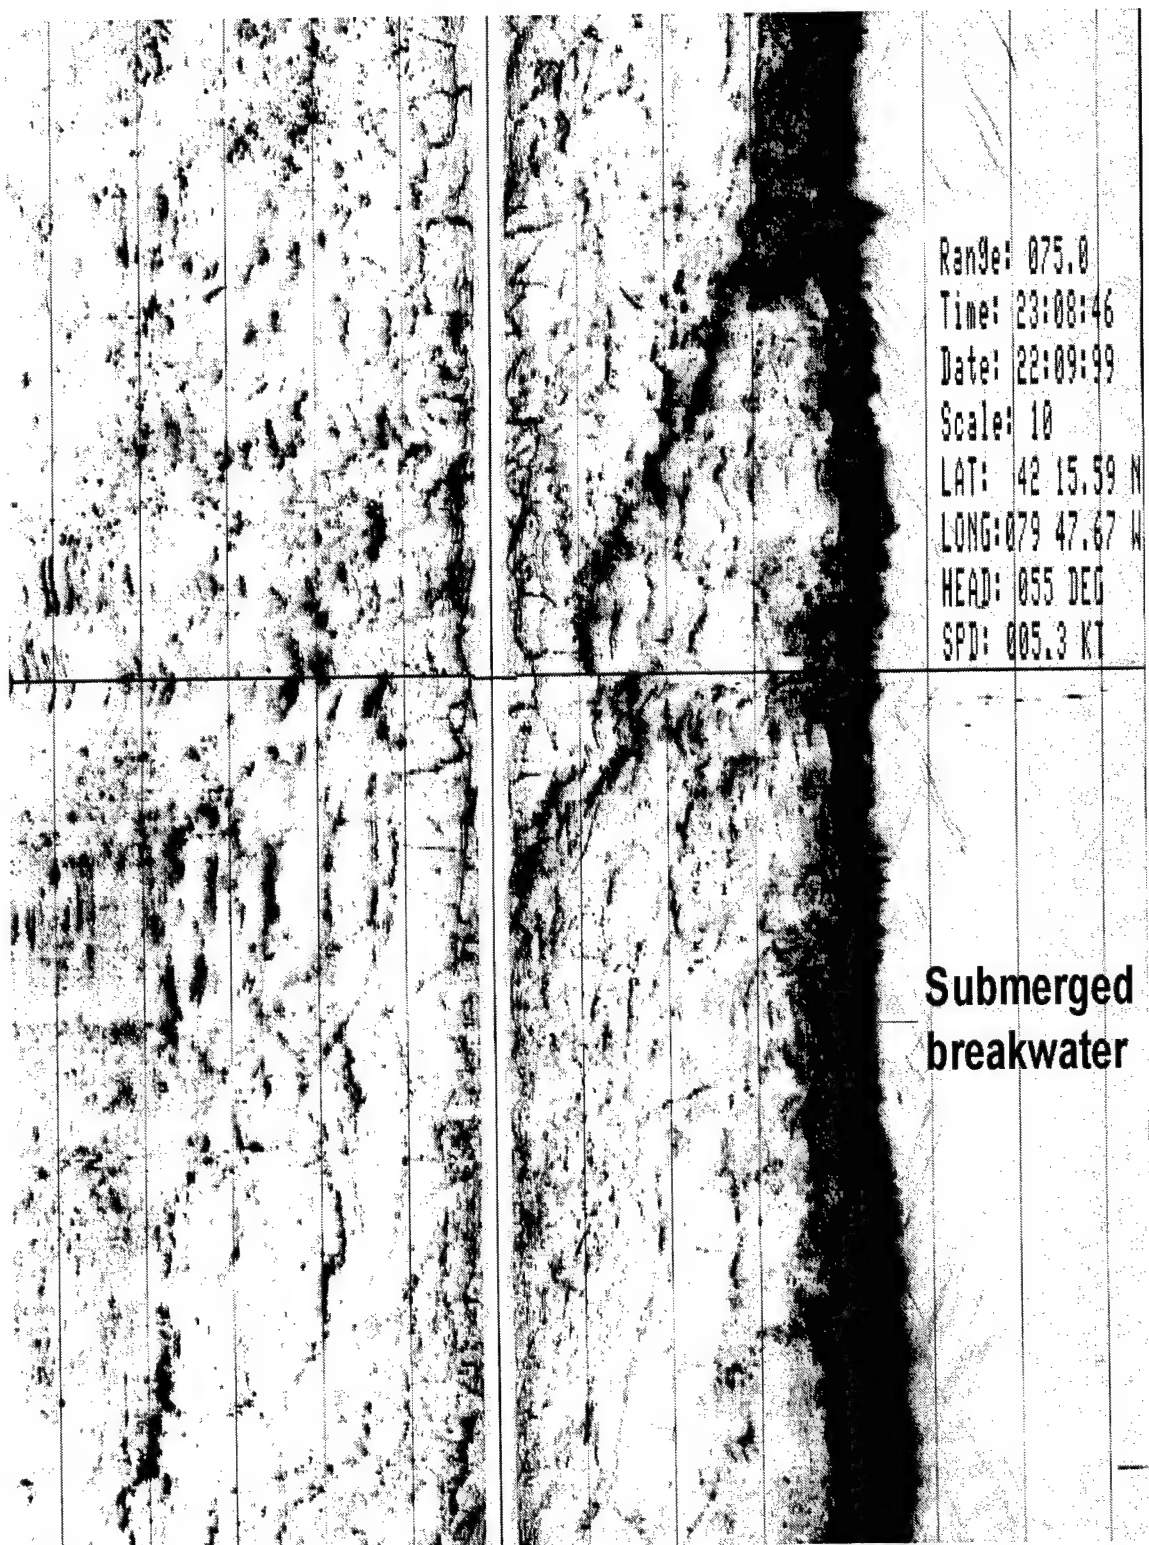
Figure 28. Sonograph immediately off marina wall, approximately halfway between east and west corners. Ship was heading NE paralleling wall. Scale between vertical lines is 10 m, and northeast is to top of page. Dark area to right is highly-reflective submerged portion of breakwater. Bedrock jointing and bedding and lack of sand is clearly shown on record

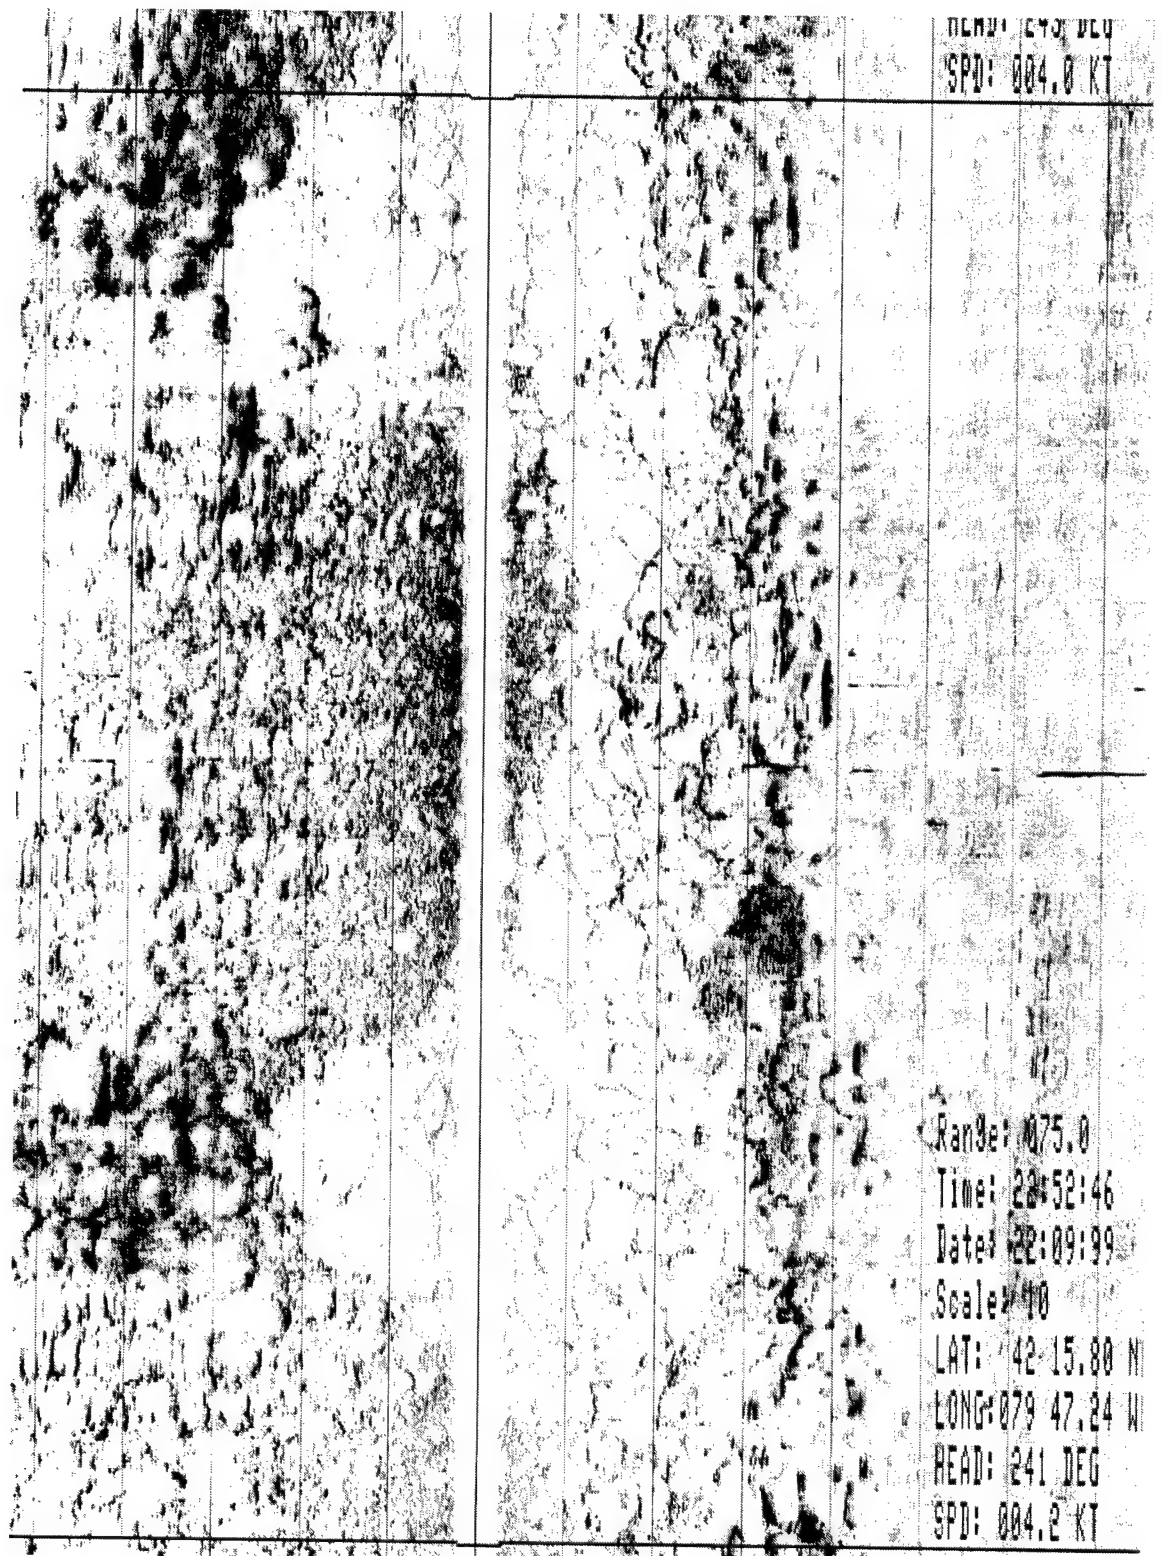
Figure 29. Sonograph, SW of the marina wall, shows additional bedrock jointing and bedding exposed on lake bed, with no evidence of sand. Ship heading was SW and distance from shore was approximately 250 m

- c. Off the marina wall and west of the marina, the bottom consisted of shale slabs with fractures and some rubble. No sand could be seen in the sonographs made off the north rubble wall of the marina (Figure 29).
